DESIGN CONSULTATION REPORT (NMK#01 1119)

IMPACT TESTING OF 12mm CLEAR TOUGHENED SAFETY GLASS INTO VETROMOUNT SURFACE MOUNTED CHANNEL SYSTEM

Design Consultation Report: NMK# 01 1119

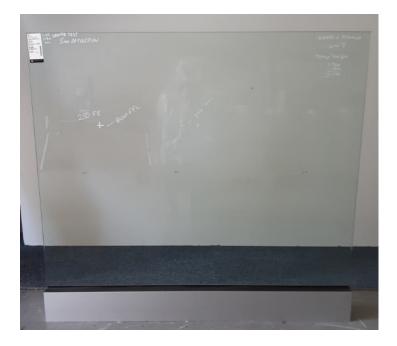
The glass panel tested was 12mm Clear Toughened Safety Glass, 1250(w) x 1100(h), supplied by National Glass Distribution, glazed into the Bohle VetroMount surface mounted aluminium channel system. The glass was secured to the channel every 250mm with Bohle's plastic mounting elements supplied and a rubber gasket to seal the system. The channel was secured to the slab using 10mm x 100mm Hilti HUS3 anchors at 400mm centres. No handrail was present on the test specimen.
